Aviation Investigation Final Report

Location:	Galliano, Louisiana	Accident Number:	CEN23FA071
Date & Time:	December 29, 2022, Local	Registration:	N595RL
Aircraft:	Bell 407	Aircraft Damage:	Substantial
Defining Event:	Dynamic rollover	Injuries:	4 Fatal
Flight Conducted Under:	Part 135: Air taxi & commuter - Non-scheduled

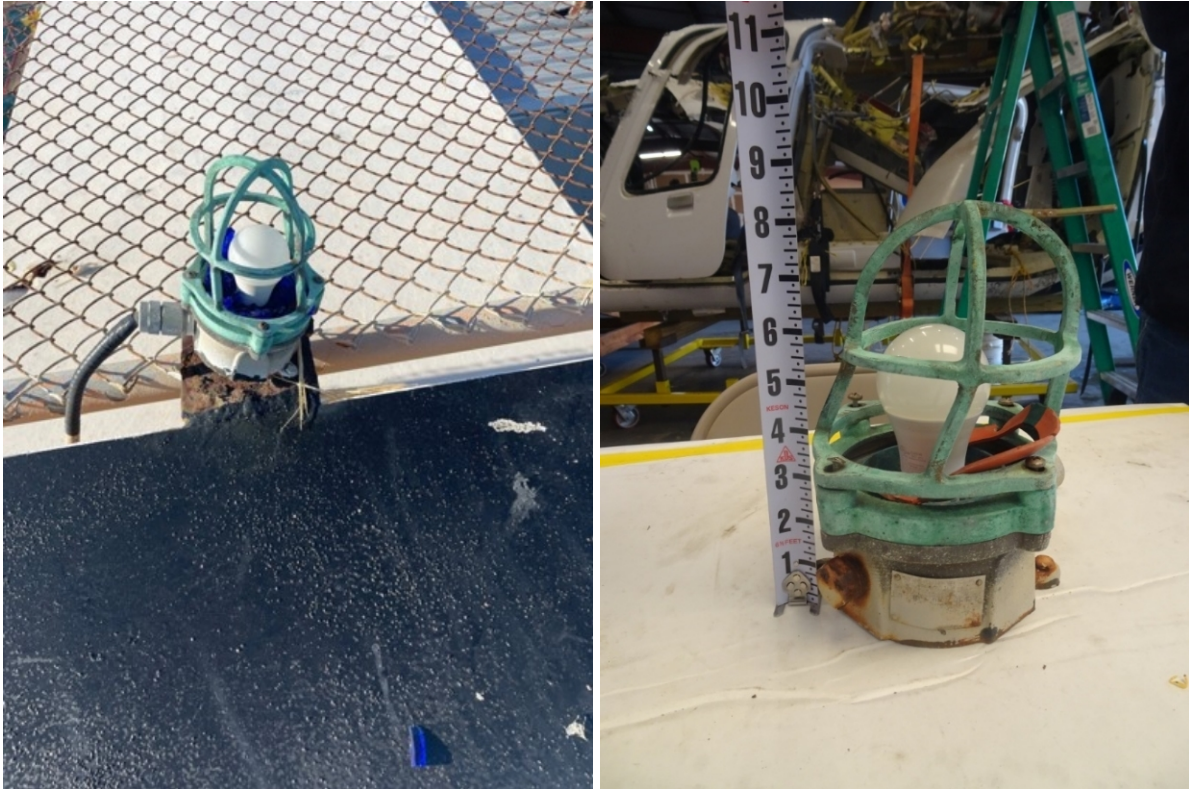
Further examination of the helideck revealed that the center blue light assembly on the northwest elevation of the helideck was damaged but still attached to its 6 inch by 6 inch light mount. Although the light remained installed on the mount, its blue glass globe was fragmented and the metal protective guard for the globe was significantly deformed and bent toward the stairwell, as shown in Figure 2. After the accident, a platform employee removed the damaged light assembly from the mount out of concern for safety during future use of the helideck. The amber light, located on the west corner of the helideck, near the stairwell, separated from its mount and was not recovered. The remaining perimeter lights appeared undamaged.

Figure 2. Photo (left) of the damaged center perimeter light shortly after the accident (Source: Walter Oil and Gas). Photo (right) of the same light assembly after it was removed from the helideck (Source: NTSB).

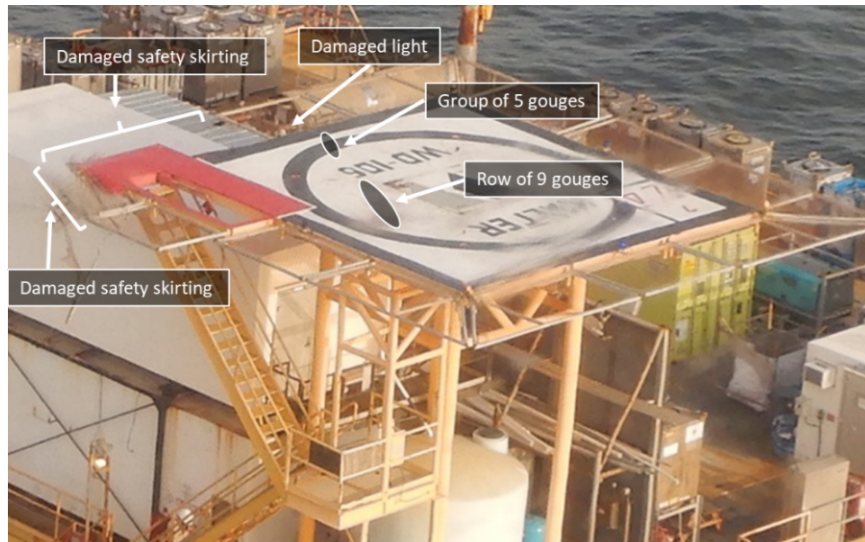
Two areas of gouges in the paint on the helideck were present. The first area was a row of nine irregularly spaced but inline gouges, as depicted in Figure 3, located inside the aiming circle and adjacent to the "W" icon logo painted on the helideck. The second area was a group of five irregularly spaced gouges, found in the black paint of the aiming circle, near the northeast side and near the damaged center light. Figure 4 is an illustration showing the location of the two areas of paint gouges and the damaged light assembly.

Figure 3. Image identifying some of the damage to the helideck.

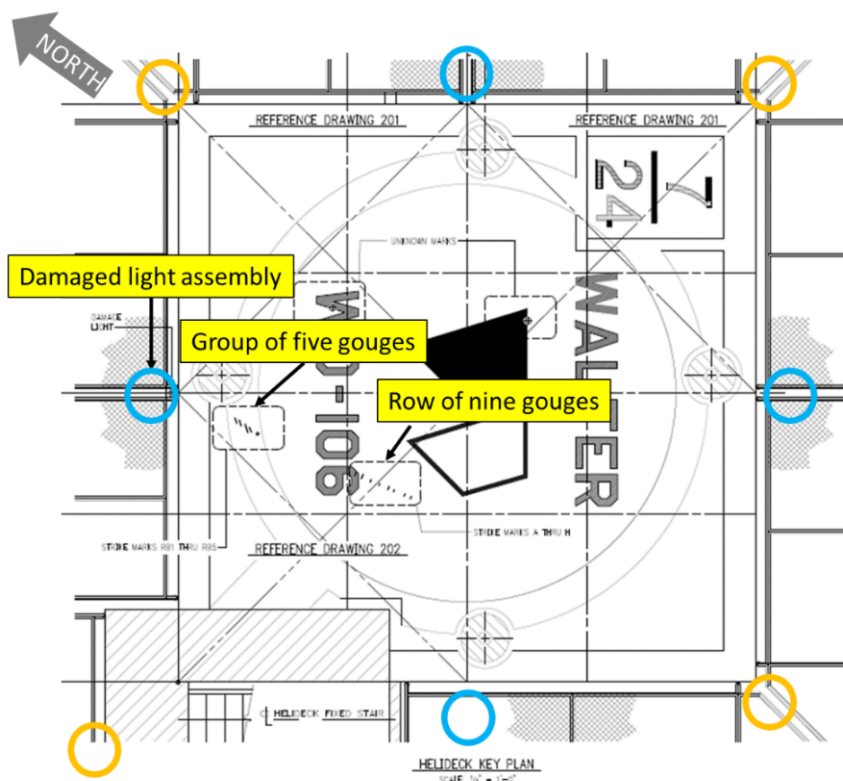
Figure 4. Illustration depicting the location of the two groups of gouges in the helideck paint and the location of the damaged perimeter light assembly.

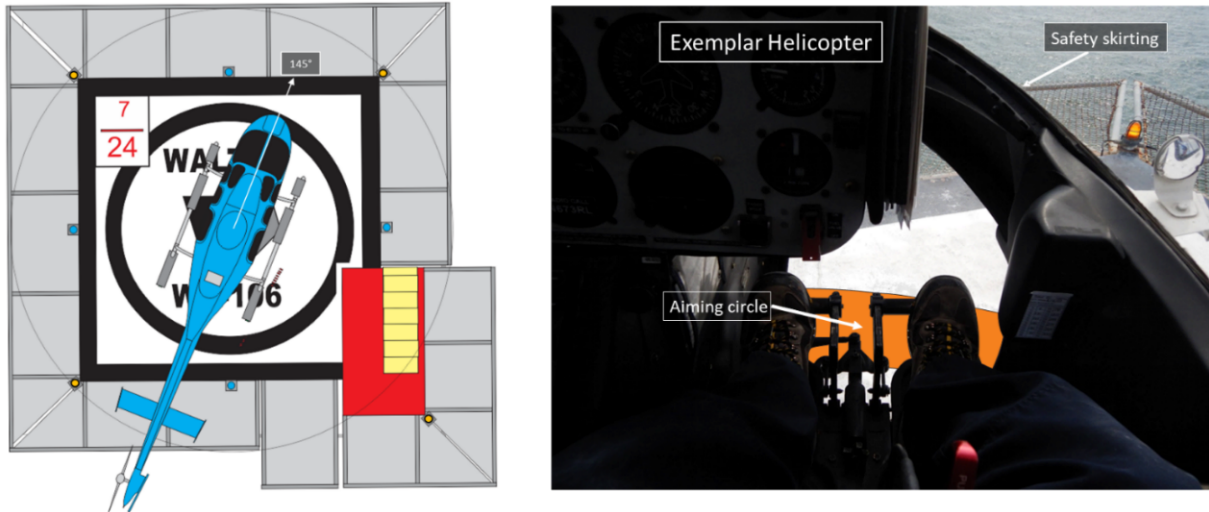
helicopter's Appareo FOV. The exemplar helicopter was flown to WD-106 and parked in the center of the 10-ft-diameter aiming circle on a magnetic heading of 145°. With a camera placed alongside the Appareo recorder, a photo was captured to show the view of the aiming circle from the right-side pilot's chin bubble. The aiming circle was positioned under the anti-torque pedals, as shown in Figure 5.

Figure 5. Photo (right) captured while the exemplar helicopter was in the center of the aiming circle and showing the right-side chin bubble and the location of the aiming circle, highlighted in orange, under the anti-torque pedals. The illustration (left) depicts the exemplar helicopter's position and orientation on the helideck.

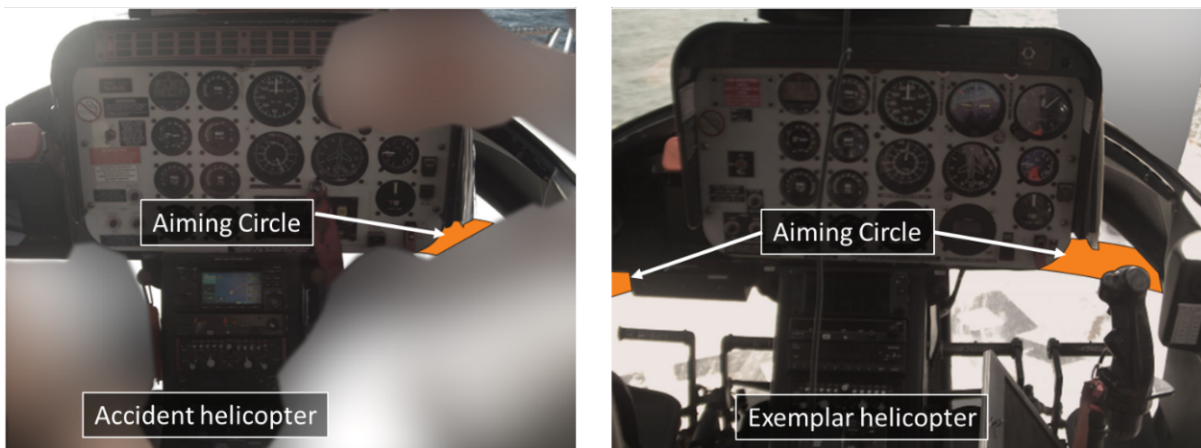
The exemplar helicopter was then repositioned straight aft on the helideck to match the accident recorder's FOV before the takeoff, as shown in Figure 6.

Figure 6. Side-by-side comparison of the accident helicopter's Appareo FOV (left) and the exemplar helicopter's Appareo FOV (right). Aiming circles are highlighted in orange.

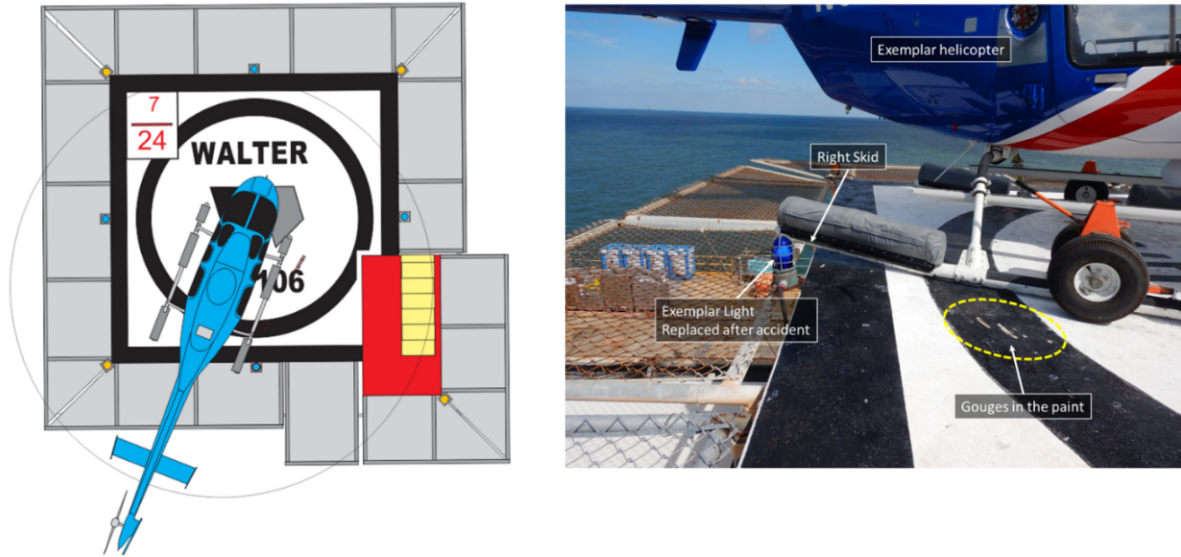
Moving the exemplar helicopter straight aft to match the accident FOV resulted in the right skid extending past the edge of the helideck, while the left skid remained completely on the helideck, as shown in Figure 7.

Figure 7. Photo (right) showing the aft section of the exemplar helicopter’s right skid beyond the edge of the northwest side of the helideck. The illustration (left) depicts the exemplar helicopter’s location on the helideck.

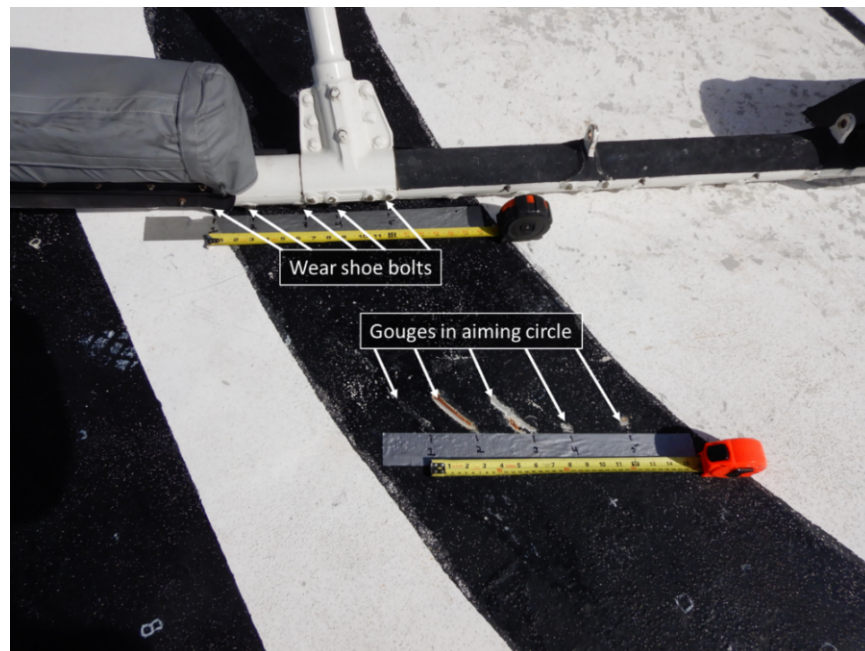
When compared to the group of five gouges in the aiming circle, the exemplar helicopter’s five wear shoe mounting bolts were near the gouges and matched the spacing between the gouges, as shown in Figure 8.

Figure 8. Photo of an exemplar helicopter's right skid showing the five wear shoe mounting bolts that matched the spacing of the group of five irregularly spaced gouges in the helideck paint.

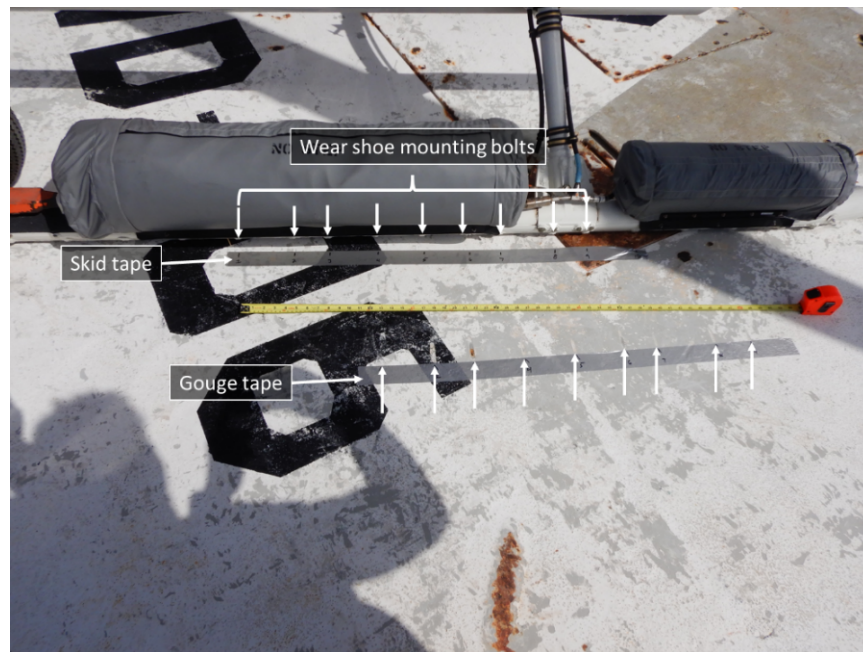
With the exemplar helicopter still in the position that matched the accident helicopter's FOV, the middle section of the right skid was compared to the row of nine irregularly spaced but inline gouges to the helideck paint. A section of nine wear shoe mounting bolts were near the gouges and matched the spacing of the gouges, as shown in Figure 9.

Figure 9. Photo showing the row of nine irregularly spaced but inline gouges in the paint alongside the matching wear shoe mounting hardware.
