# Aviation Investigation Final Report

| <b>Location:</b> | Soldotna, Alaska | <b>Accident Number:</b> | ANC20LA074 |
| <b>Date &amp; Time:</b> | July 31, 2020, 08:27 Local | <b>Registration:</b> | N4982U (A1);<br>N2587M (A2) |
| <b>Aircraft:</b> | De Havilland DHC-2 (A1); Piper PA 12 (A2) | <b>Aircraft Damage:</b> | Substantial (A1);<br>Substantial (A2) |

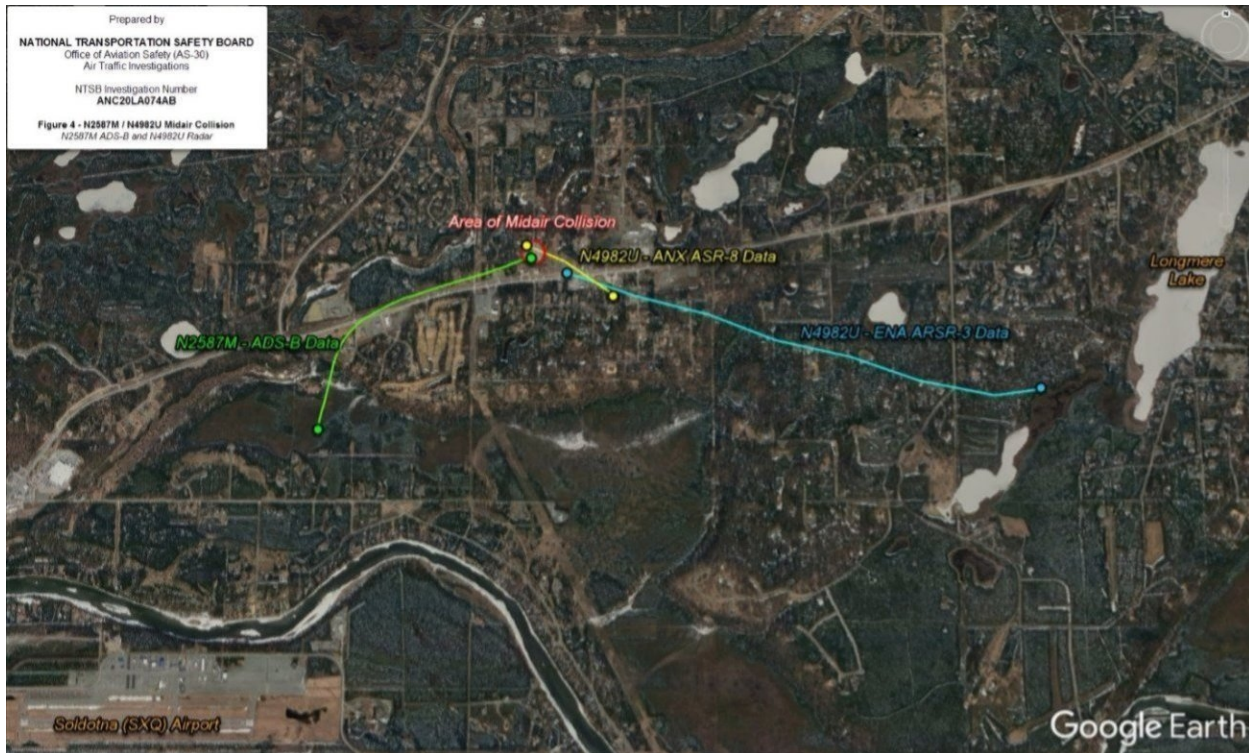
Flight track data revealed that the DHC-2 was traveling northwest about 78 knots (kts) groundspeed and gradually climbing through about 1,175 ft mean sea level (msl) when it crossed the Sterling Highway. The PA-12 was traveling northeast about 1,175 ft msl and about 71 kts north of, and parallel to, the Sterling Highway. The airplanes collided about 2.5 miles northeast of the Soldotna airport at an altitude of about 1,175 ft msl. See figure 1 for the airplanes' flight tracks.

Figure 1 - Flight track. ADS-B data (N2587M) and ENA/ANX radar data (4982U).

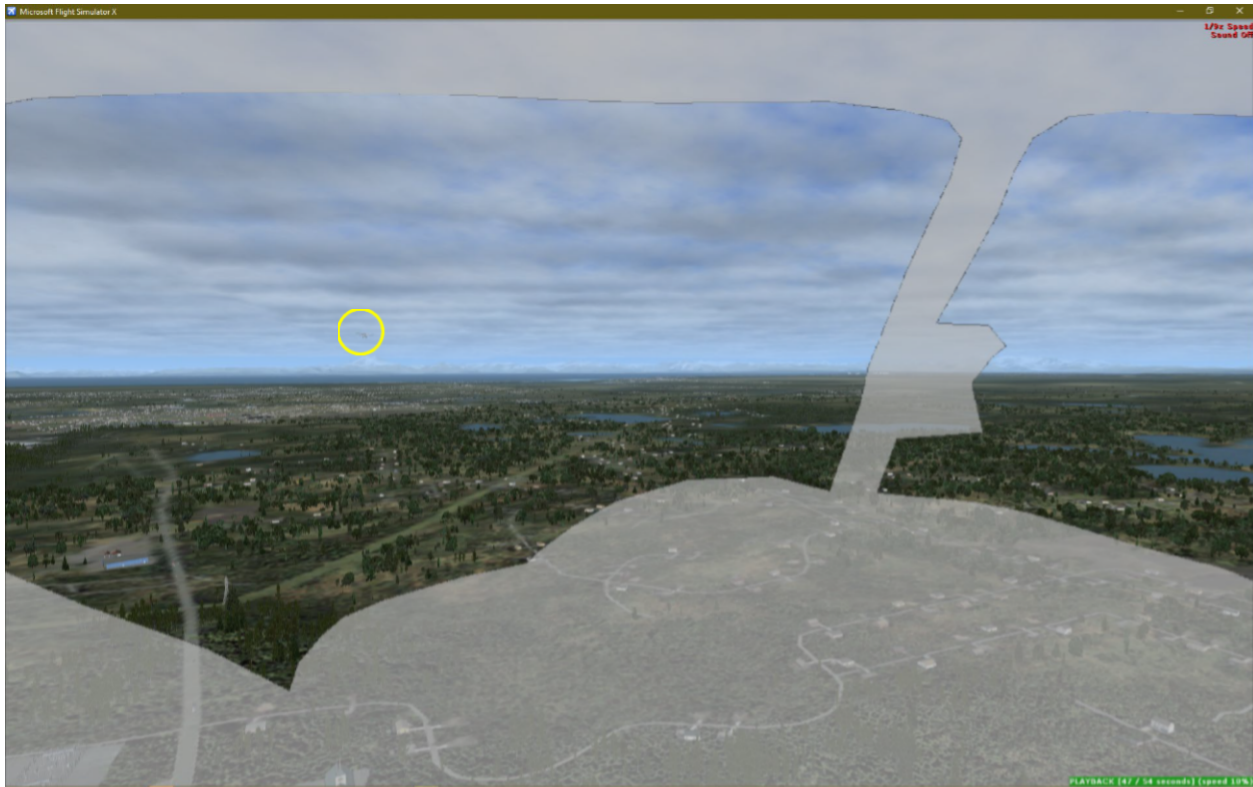
The cockpit visibility study revealed that for the 53-second period before the collision, the Piper would have been unobscured and visible from the DHC-2 pilot through the DHC-2 left windshield.

Figure 2 - Recreation of the view from the DHC-2 cockpit at 0826:27 (5.3 seconds before the collision). The location of the PA-12 is indicated by the yellow circle.

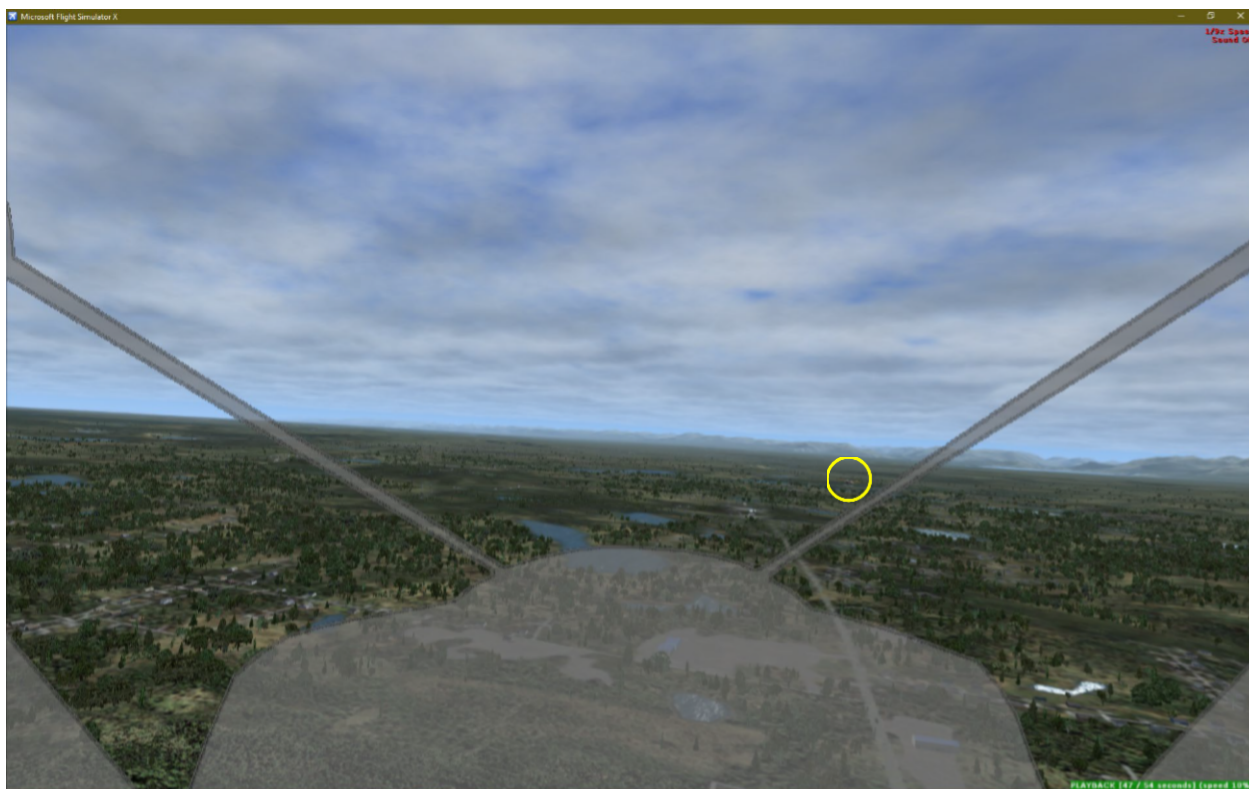
Regarding whether the PA-12 pilot could have seen the DHC-2, between 0825:39 to just before 0825:51 (12 seconds) the DHC-2 would have been unobscured and visible through the PA-12 right window. The DHC-2 would have then been obscured behind the PA-12 right wing root until about 0825:58. The DHC-2 would then have appeared on the right edge of, or been obscured by, a structural support tube inside the cockpit from about 0825:58 to about 0826:04 (6 seconds). From 08:26:04 to the collision at 08:26:32.3 (28.3 seconds), the DHC-2 would have been unobscured and visible in the PA-12 windshield, just to the left of the support tube.

Figure 3 - Recreation of the view from the Piper cockpit at 0826:27 (5.3 seconds before the collision). The location of the DHC-2 is indicated by the yellow circle.
